Subject: Metropolitan Wastewater Treatment Plant
Operating Permit 879-90-OT-3
Summary of Emergency Damper Leakage

SUMMARY OF
EMERGENCY DAMPER LEAKAGE

METRO PLANT INCINERATORS

September 1995 through February 1996

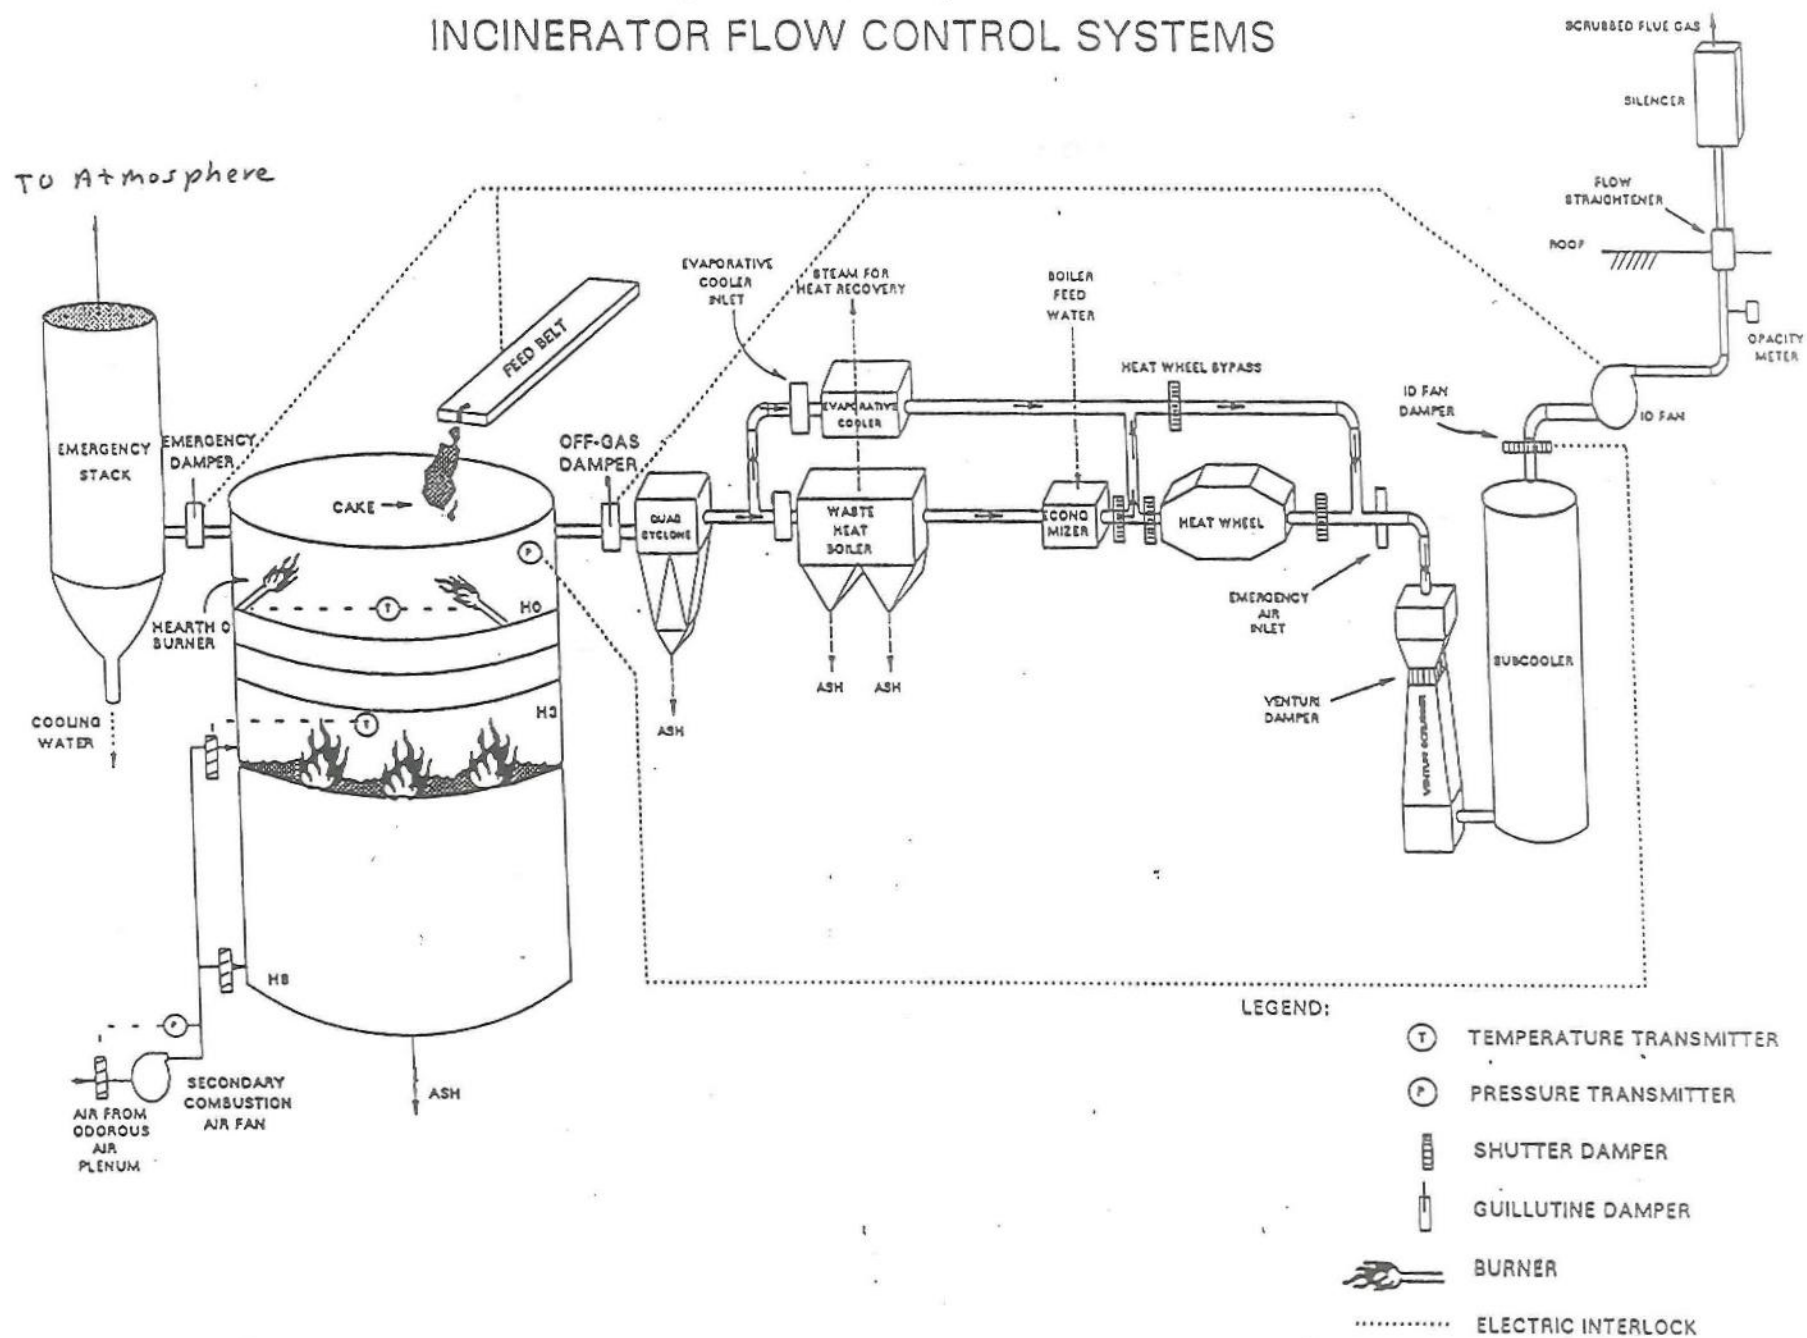
FIGURE 1
INCINERATOR FLOW CONTROL SYSTEMS

When the ID fan is unable to withdraw the hot flue gas, that gas must be vented through the emergency damper to the emergency stack, where a natural draft discharges it to the atmosphere. This is an essential safety feature for an incinerator. Without the emergency damper/stack arrangement, failure of the ID system would cause hot flue gas to vent directly into the incinerator building. Severe damage to equipment and injury to personnel would result. The emergency stack arrangement is shown in Figure 1.

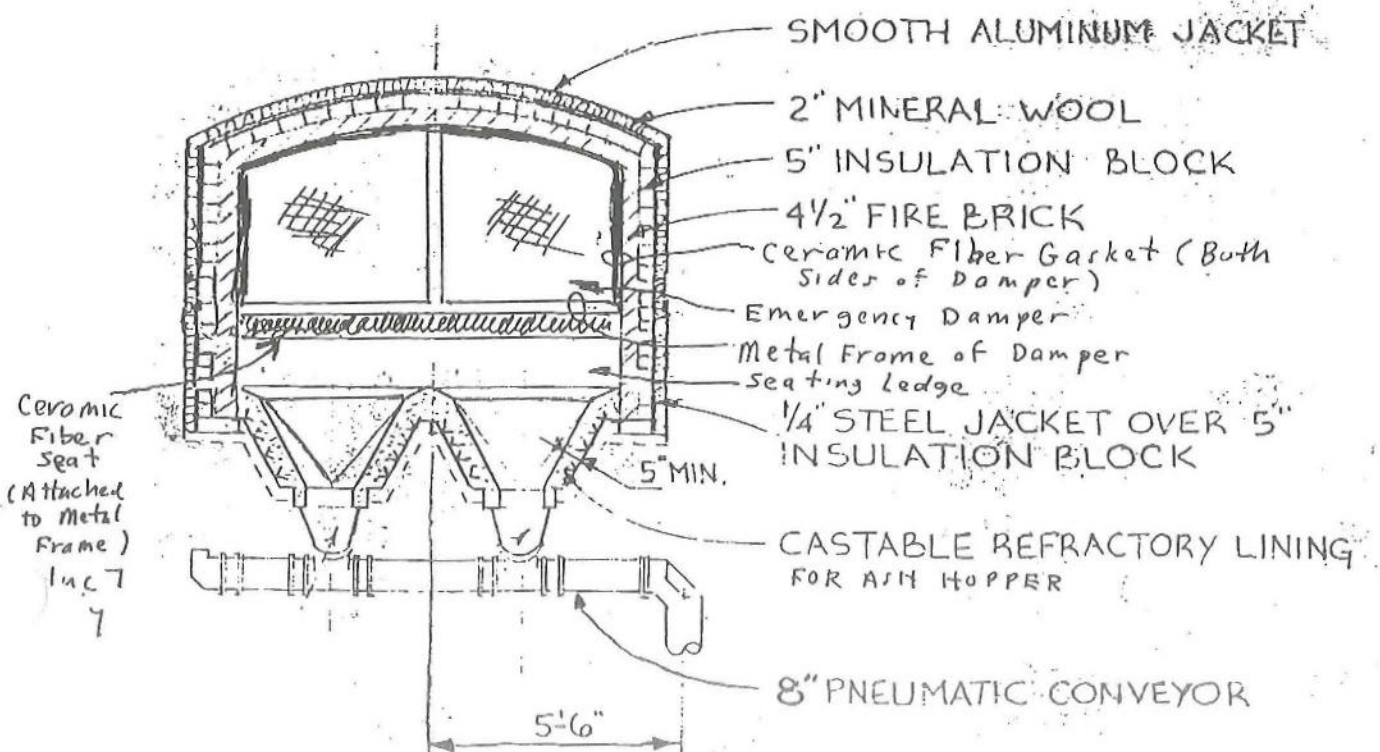
FIGURE 3
VIEW OF EMERGENCY BREACH/DAMPER FROM INSIDE HEARTH

The seat area, where the metal damper frame meets the hard refractory ledge, is the other focus of concern. There definitely appears to be potential for a bad seal in this area that can allow leakage. The failure to achieve a tight seal is certainly, but perhaps not exclusively, related to ash. The leakage of Inc. 8 during January 1996, for instance, was halted by blowing ash away from the seat area. In the on-going case of Inc. 10, however, the same measures have not proven effective. In any event, the seat is an area that requires attention.

The more important seat modification is the addition of a layer of ceramic fiber refractory material to the bottom of the metal damper frame, as shown in Figure 3. This material extends across the entire width of the damper, has a height of 6 inches and a thickness of 4 inches. The intent is to provide a compressible layer between the hard surfaces of the damper frame and refractory ledge. It will allow a good seal to be maintained if some ash lies on the ledge as the damper descends, or if the damper closes in an imperfectly level position.

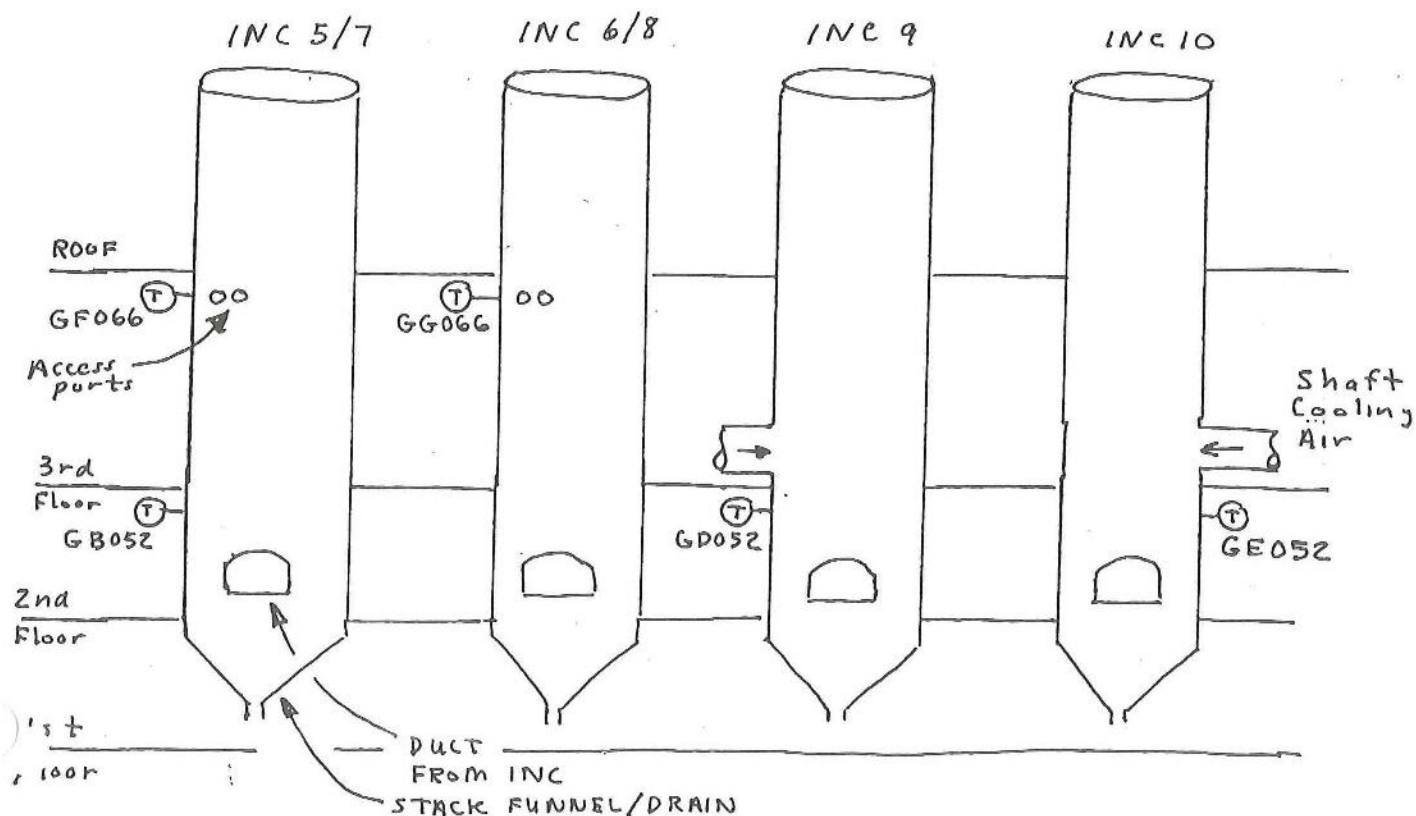
FIGURE 4

the plant computer system on each emergency stack. Monitoring of stack temperatures provides a positive indication of the presence of leakage. Figure 4 shows the monitoring configuration that was ultimately installed.

GB 052 T T - 5/7 Stack, top of 2nd floor
 GF 066 T T - 5/7 Stack, below roof line
 GG 066 T T - 6/8 Stack, below roof line
 GD 052 T T - Inc, 9 Stack, top of 2nd floor
 GE 052 T T - Inc 10 Stack, top of 2nd floor

After this second episode, it became obvious that a better method of detecting leakage than visual observation was needed. On October 17, a work order was generated for Metro Maintenance to install thermocouples with temperature transmitters connected to

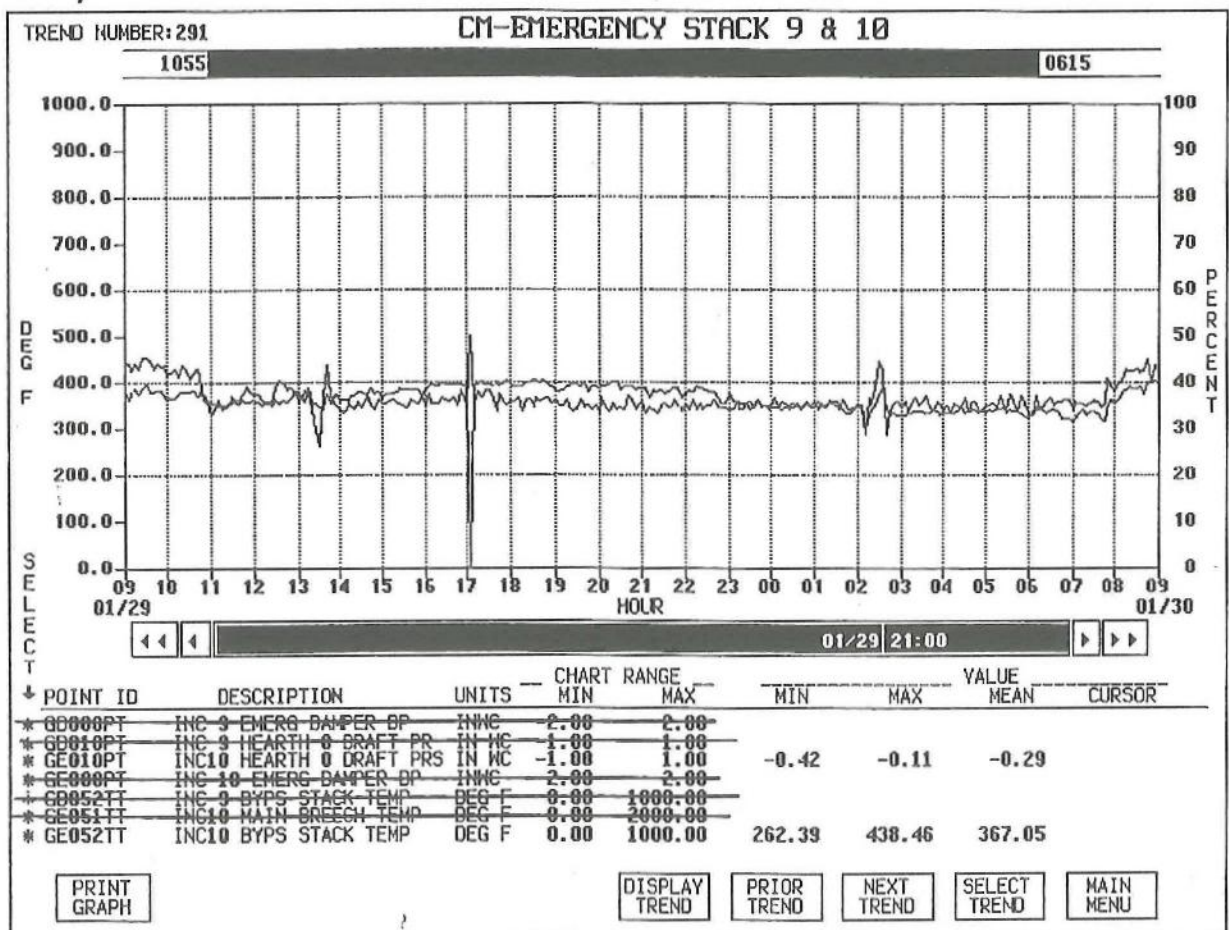
The final leakage situation involves Inc. 10. Leakage was observed from the emergency stack on January 26 and was verified by stack temperature data. Figure 5 illustrates this situation. Ash was removed from both sides of the damper on the same day. Portions of the sealing gasket on the downstream side of the emergency damper were seen to be missing. The seat area was cleaned with the air lance. The same actions were repeated on January 29 and January 31 since the stack was still leaking after January 26. A high draft was used, but even so leakage continued into the first part of February. The draft setpoint had to be raised to values as high as -0.5" to control the leakage.

Inc 10 - Leakage Up Emergency Stack at Moderate Draft

Inc 10 draft running from -0.11 to -0.42 ", with a mean value of -0.29 ". These values are higher than normal, but not as high as the -0.4 to -0.5 " needed to halt leakage. Stack temp ranges from 262 to 438 °F, indicating leakage past the emergency damper

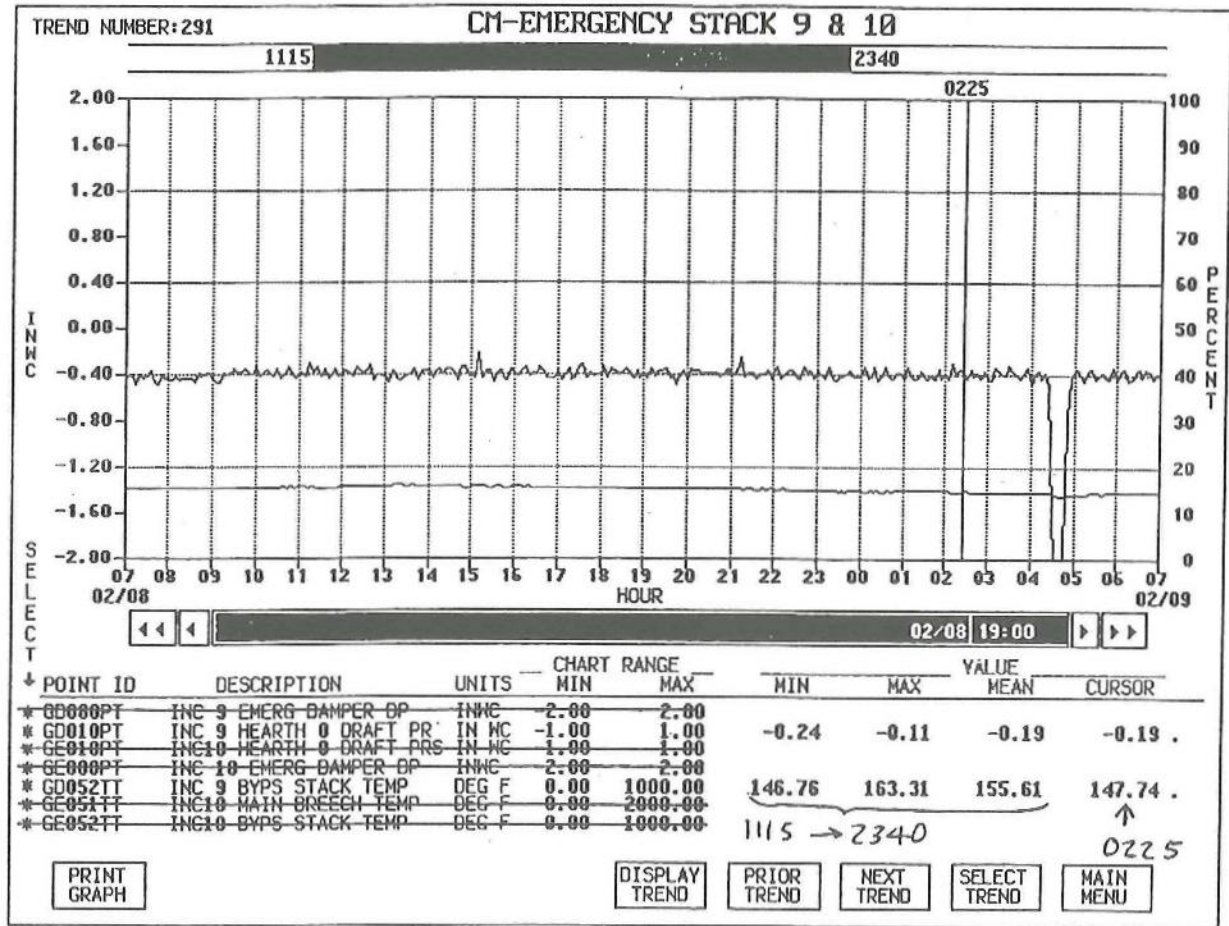
FIGURE 6

No leakage at normal draft Inc # 9.

With the draft ranging from $-0.1''$ to $-0.24''$ WC, the stack temp is between 145°F and 165°F . No leakage is occurring. The stack temp does not drop down to outdoor levels because of the introduction of hot shaft cooling air (200°F) into the emergency stack right above the thermocouple. (This arrangement applies to Inc 9 and 10 only.)

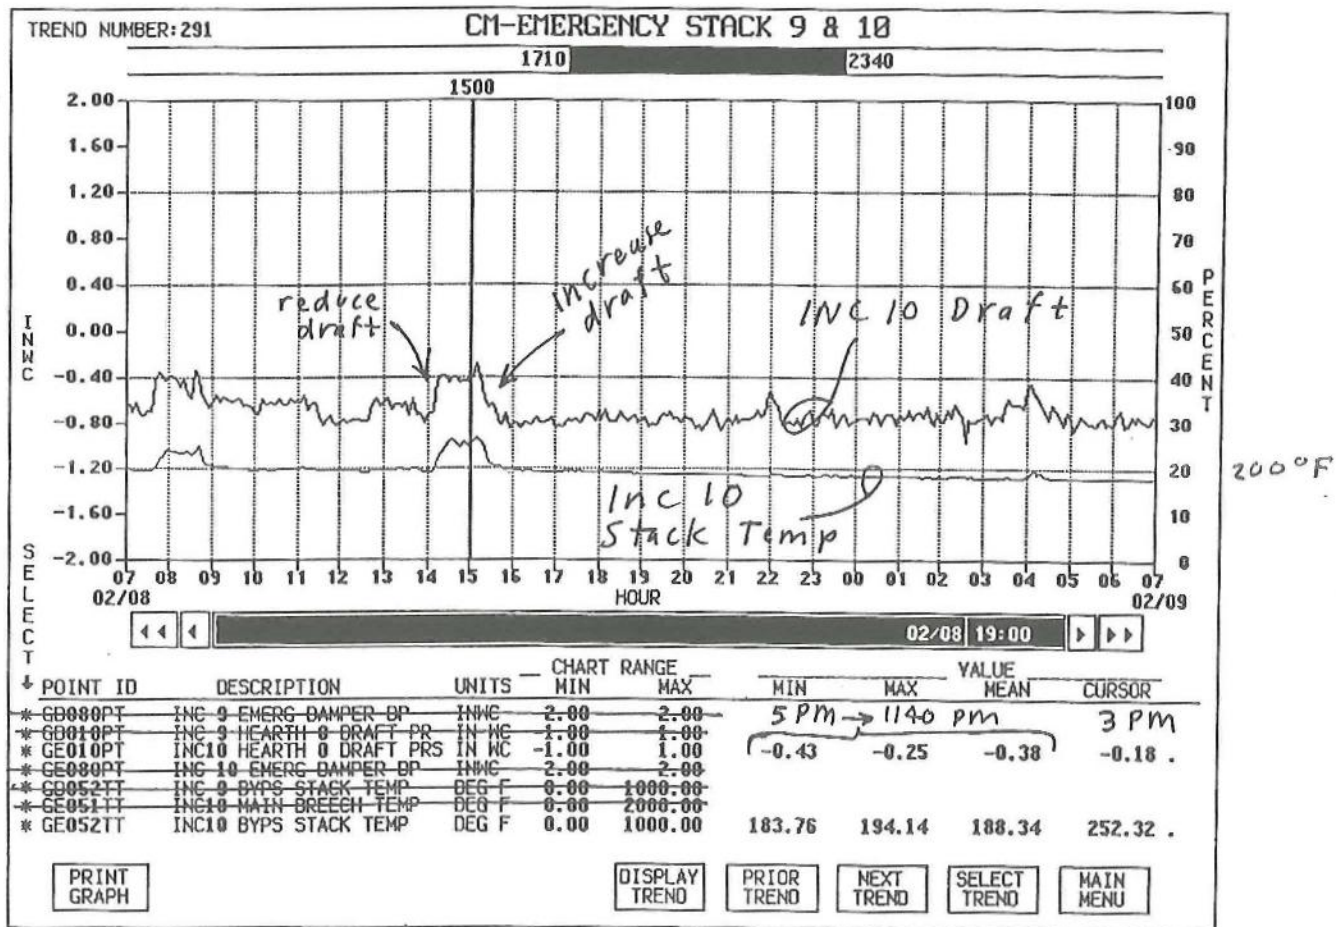
FIGURE 7

Five incinerators, covering all four emergency stacks, are in service. Temperatures in the emergency stacks show that no leakage is occurring. In the case of Incinerator 10, however, the draft must be held at a high value (-0.4" to -0.5" WC) to prevent leakage. Figure 6 illustrates a typical case of no leakage under normal draft conditions. Figure 7 shows a high draft on Inc. 10 being used to prevent leakage.

Leakage on Inc 10 Prevented by High Draft.

At 1400 the draft was returned to normal to see whether leaking would resume. It did, as indicated by the stack temp increase to 252°F. Draft again increased at 1530, and stack temp dropped below 200°F, showing that leakage was back under control.
